BUILDING INFORMATION REPORT

Facility:	LIBBY	Building Name:	DEPOT
City:	LIBBY, MT	Building Number:

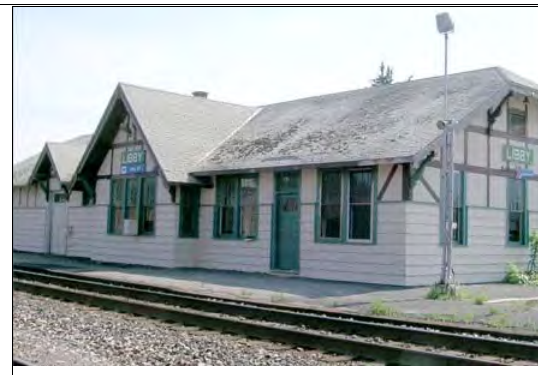
**Inspection Date: 10/20/1994**

Sample Number	Description	General Area	Class	Amount	Units	Condition	Asbestos Type	Status
LIB-DP-01	9" FLOOR TILE/MASTIC	PASSENGER AND CLERK AREA	N.F. I	720	S.F.	DAMAGED	CHRYSTILE	SOLD
LIB-DP-02	9" FLOOR TILE/MASTIC	PASSENGER & CLERK AREA	N.F. I	720	S.F.	DAMAGED	CHRYSTILE	SOLD
LIB-DP-03	12" X 24" CEILING TILE	PASSENGER & CLERK AREA	N/A	0	S.F.	N/A	NON-ACM	SOLD
LIB-DP-04	PLASTER	EXTERIOR (UPPER HALF)	N/A	0	S.F.	N/A	NON-ACM	SOLD
LIB-DP-05	ASPHALT SHINGLES	ROOF	N/A	0	S.F.	N/A	NON-ACM	SOLD
LIB-DP-06	VINYL FLOORING	ROOM NEXT TO BOILER ROOM	N/A	0	S.F.	N/A	NON-ACM	SOLD
LIB-DP-900	INSULATION	BOILER JACKET	FRI.	20	L.F.	GOOD	ASSUMED ACM	SOLD

Sample Number	Description	General Area	Class	Amount	Units	Condition	Asbestos Type	Status
LIMT-DPB-701	PLASTER	EXTERIOR	N/A	0	S.F.	N/A	NON-ACM	SOLD
LIMT-DPB-702	PLASTER	EXTERIOR	N/A	0	S.F.	N/A	NON-ACM	SOLD

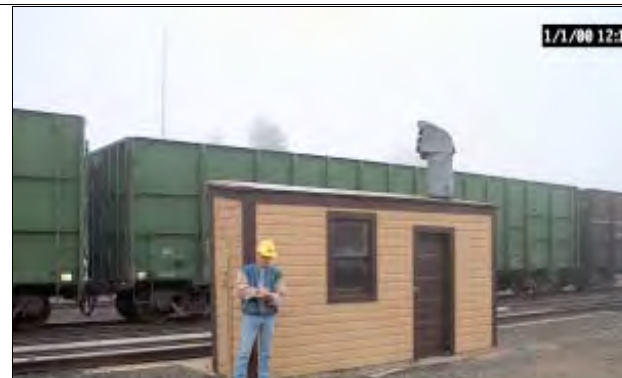
Sample Number	Description	General Area	Class	Amount	Units	Condition	Asbestos Type	Status
LIB-SC-01	SHINGLES	ROOF	N/A	0	S.F.	N/A	NON-ACM	DEMO

Sample Number	Description	General Area	Class	Amount	Units	Condition	Asbestos Type	Status
LBMT-SCH-003	ASPHALT SHEETING	ROOFING TOP LAYER	N/A	0	S.F.	N/A	NON-ACM	DEMO
LBMT-SCH-005	ASPHALT SHEETING	ROOF BOTTOM LAYER	N/A	0	S.F.	N/A	NON-ACM	DEMO
LBMT-SCH-006	ASPHALT SEALANT	ROOF	N/A	0	S.F.	N/A	NON-ACM	DEMO

Sample Number	Description	General Area	Class	Amount	Units	Condition	Asbestos Type	Status
LBMT-SCH-001	FIBERBOARD	NORTH INTERIOR WALL	N/A	0	S.F.	N/A	NON-ACM	DEMO
LBMT-SCH-004	TAR PAPER	ROOF MIDDLE LAYER	N/A	0	S.F.	N/A	NON-ACM	DEMO
LBMT-SCH-007	TAR SEALANT	ROOF	N.F. I	40	S.F.	DAMAGED	CHRYSTOTILE	REMOVED-DEMO 9/20/2004
LBMT-SHB-002	WINDOW CAULKING	EXTERIOR WINDOWS	N.F. I	30	L.F.	DAMAGED	CHRYSTOTILE	REMOVED/DEMO 9/20/2004

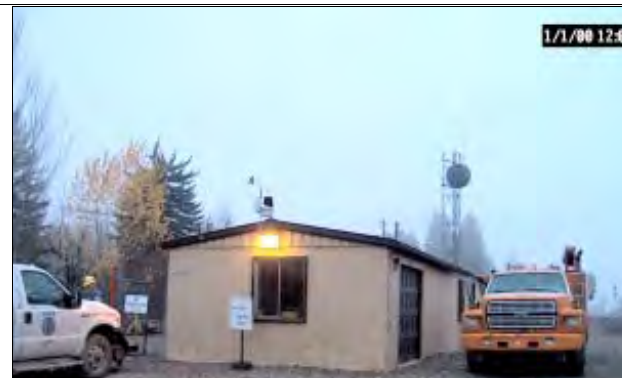
**Inspection Date: 3/13/2001**

Sample Number	Description	General Area	Class	Amount	Units	Condition	Asbestos Type	Status
LIMT-SHB-001	VERMICULITE	ATTIC	N/A	1008	S.F.	SIGNIFICANTLY DAMAGED	NON-ACM	REMOVED 4/26/2001
LIMT-SHB-001A	VERMICULITE	ATTIC EAST END	N/A	1008	S.F.		ACTINOLITE	REMOVED 4/26/2001
LIMT-SHB-002	VERMICULITE	ATTIC	N/A	1008	S.F.	SIGNIFICANTLY DAMAGED	NON-ACM	REMOVED 4/26/2001
LIMT-SHB-002A	VERMICULITE	FURNACE ROOM	N/A	1008	S.F.		TREMOLITE	REMOVED 4/26/2001
LIMT-SHB-003	VERMICULITE	ATTIC	N/A	1008	S.F.	SIGNIFICANTLY DAMAGED	NON-ACM	REMOVED 4/26/2001
LIMT-SHB-003A	VERMICULITE	ATTIC CRAWL SPACE WEST END	N/A	1008	S.F.		NON-ACM	REMOVED 4/26/2001
